# Restoring An Audio Classic, The SME 3009 Series II Tonearm

By Brian Kearns

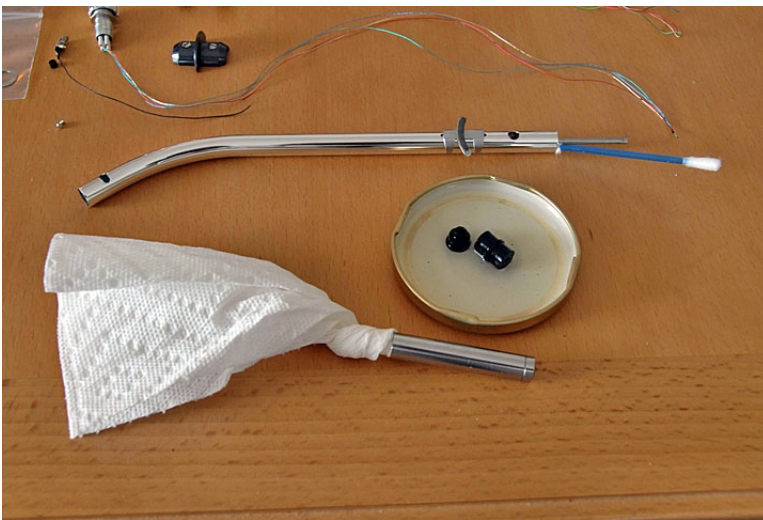
Photo 3 – Cleaning out the tonearm tube and rear stub.

So I began by preparing the tools and dismantling the tonearm, which is very easy to do. Separating the stub from the tonearm tube is achieved by pulling and twisting the two pieces; ideally the old rubber section will not fully disintegrate during this step, so that there is not an excessive amount of rubber to be removed from inside the tonearm tube and stub. Still, excess rubber will remain behind, and this needs to be cleaned from the two parts of the tonearm. Lighter fluid is the preferred solvent to remove the residue of rubber: the stub can be fully immersed in lighter fluid; and the inside of the tonearm tube can be cleaned using a soaked cotton bud – photo 2 and photo 3. It is also recommended to soak the replacement coupling rubbers in lighter fluid briefly and to wipe dry in order to remove any grease or grime that may have contaminated the outer surfaces thereof.

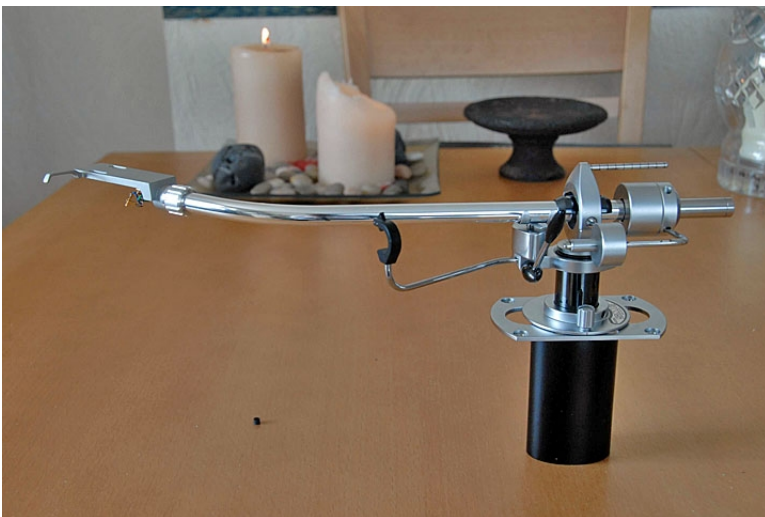
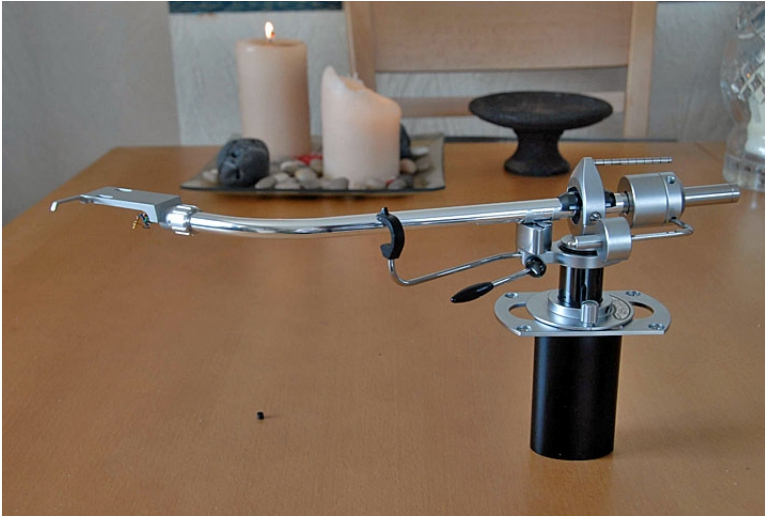
**Photo 11 and Photo 12 – Tonearm cueing mechanism set for correct up and down movement.**

Before soldering the leads to the terminals on the sliding base, it is a good idea to adjust the height of the arm cueing assembly on the pillar bearing so that the arm cues up and down from above horizontal to below – photo 11 and 12.

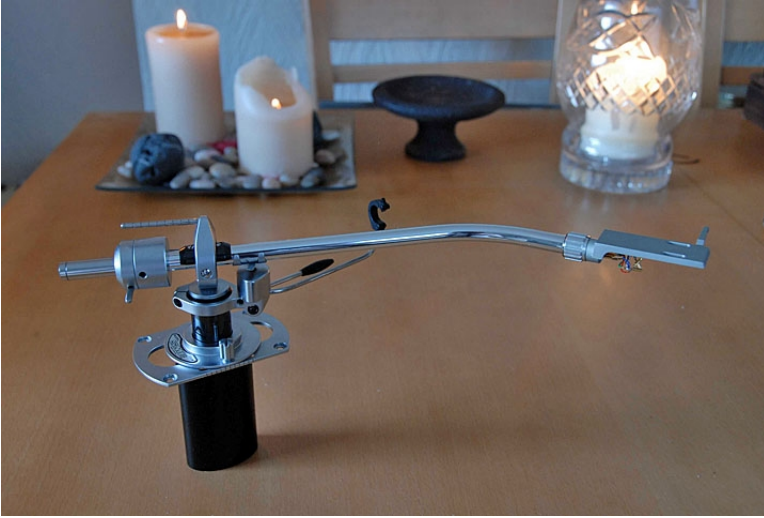
**Photo 16 – The finished product – just like how it was when Alastair Robertson-Aikman gave it his approval for packing and shipping all those years ago in the SME factory.**

The finished article looks like it should: an audio classic and a piece of industrial art that has earned its reputation through 40 years of endurance – photo 16!
